## Improving Grit Quality

Location:  
Southwestern  
USA

Reagent:  
Quicklime

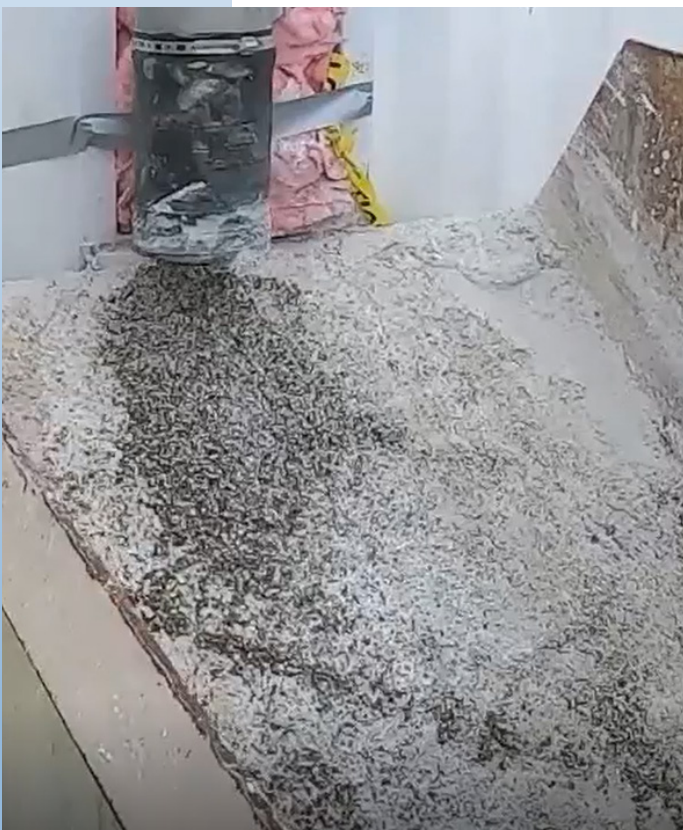
When visiting the water treatment plant in 2025, experts from Carmeuse Systems performed a visual inspection to ensure that the system was running efficiently. Upon inspection of the grit bin, it became clear that unreacted lime was in the grit. It was important to resolve this issue and ensure that the process was running correctly.

The Carmeuse Systems team sent samples of the grit to the Innovation Center for laboratory testing and it was determined that the grit showed approximately 40% available lime that was unreacted. Though the slurry testing confirmed that the slurry itself was within expected parameters, it was clear that reagent was being wasted.

- The investigation determined that the slaking temperature was too low, preventing complete hydration of the lime. Carmeuse Systems recommended increasing the slaking temperature to the target operating temperature of 185°F (85°C).
- The piping system was cleaned to address buildup and support proper system operation.
