## Improving Grit Quality

Location:  
Southwestern  
USA

Reagent:  
Quicklime

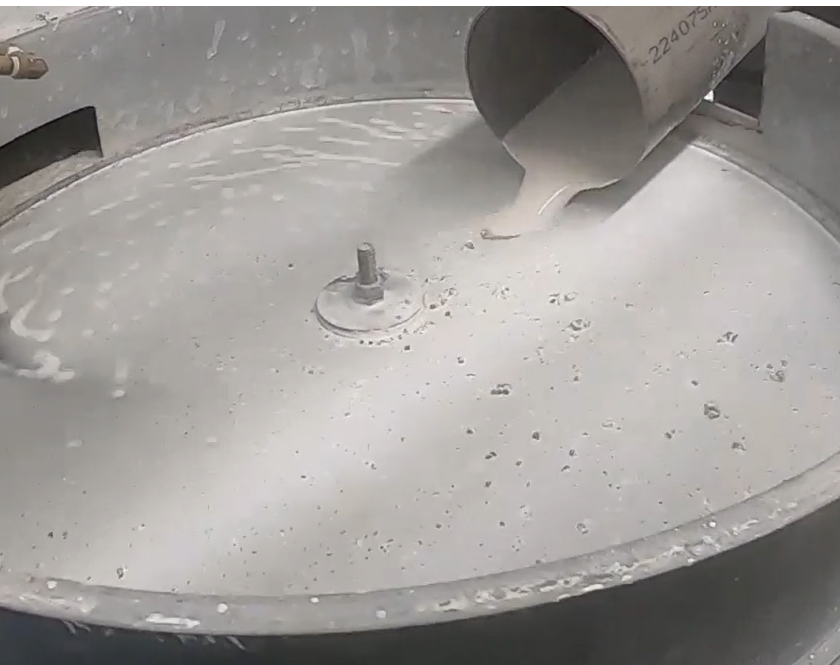
Following implementation of the recommended corrective actions, the amount of unreacted lime reporting to the grit stream was significantly reduced. By restoring proper slaking conditions, the facility improved lime utilization, reduced reagent waste, and increased overall process efficiency.

- The investigation determined that the slaking temperature was too low, preventing complete hydration of the lime. Carmeuse Systems recommended increasing the slaking temperature to the target operating temperature of 185°F (85°C).
- The piping system was cleaned to address buildup and support proper system operation.
